## Damages mapping of façade using Aerophotogrammetry and Thermography Inspection: Zoroastro Artiaga Museum – Art Deco in Brazil

**Keywords:** Art Deco Architecture; Non-destructive techniques; Aerophotogrammetry; Thermographics images; Damages map.

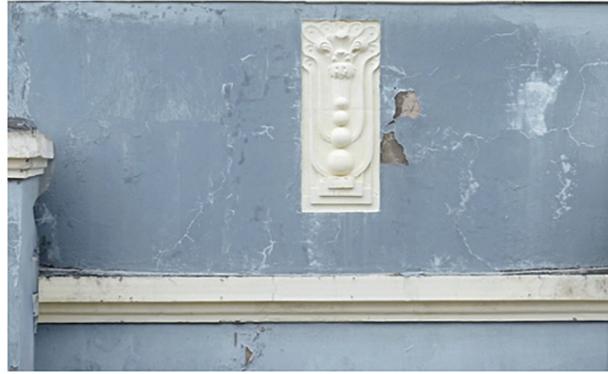
Figure 13: Detail of the main façade orthoimage of the Zoroastro Artiaga Museum.

Enlarging the orthoimage, it is possible to observe the ornament details and the efflorescence stains, paint peeling and even the cracks present in the façade with precision (Figure 13).

In Figure 13, it is observed that the efflorescence occurred predominantly in the region close to the plat-band and represented a DF equals to 4.59%. The paint blistering was verified only on the lower right part of the façade and presented a DF value of 0.95%. The appearance of parasitic vegetation occurred more in the upper part of the façade and presented the lowest DF (0.08%), possibly due to cleaning and building maintenance actions.

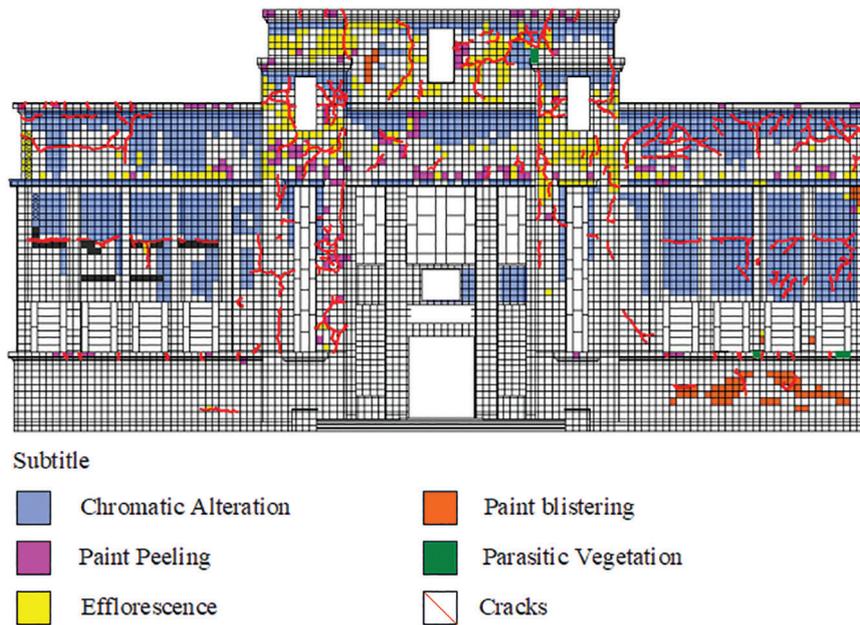
Figure 14: Damages map of the main façade of the Zoroastro Artiaga Museum.

A damages map was constructed from orthoimage analyzes and visual inspections performed at the site. In Figure 14, the damages map, generated by computational vectorization, is presented, in which the pathological manifestations visually detected were vectored by coloring and hatching in their respective areas on the façade.

It is observed that the pathological manifestation with the highest incidence on the façade area is the chromatic alteration of the paint, with DF equals to 21.3%. This pathological manifestation was possibly caused by the position of the façade, and, consequently, the effect of the sun's rays and the direction of rain.

The pathological manifestation of peeling of the paint appeared predominantly in the upper region of the museum's façade, which may be susceptible to the action of water that infiltrates through the platband, and had a DF equals to 2.49%.

It was verified, in the upper part, that there is a greater concentration of cracks, and the determined DF was equal to 0.43%. The fissure is the pathological manifestation that requires more time in its detection and mapping, and the visualization will depend on some aspects, including camera resolution and proximity to the building in the photographic record stage.

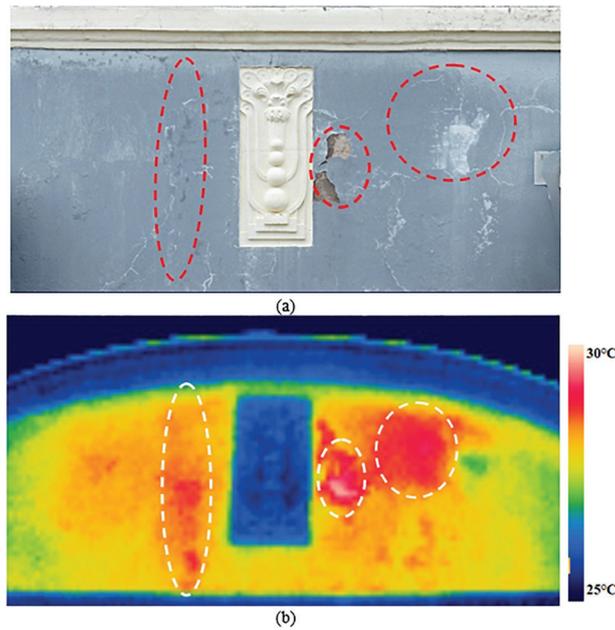
In Figure 15(a), there is a cut-out of the orthoimage and the thermogram corresponding to region 1 of the inspection by Thermography. In the orthoimage, one can see the presence of efflorescence with greater concentration to the right side of the image, accompanied by peeling of the paint near the central area.

From the thermogram, the problems of peeling in the paint observed by the damages map were corroborated. In this case, higher temperatures were represented by red and white colors in the thermogram.

Figure 15: Pathological manifestations in region 1: (a) orthoimage; (b) thermogram.

Efflorescence problems, which originate from the presence of moisture, can also be confirmed in the thermogram. The predominantly red areas (warmer than the neighboring areas without defects) are an indication of moisture presence close to the surface, considering the greater specific heat of the water and the fact that the platband receives sun from the opposite side. Moisture problems in thick masonry walls were also detected by Kominsky *et al.* [42] as the hottest areas in the inspection carried out during the day.

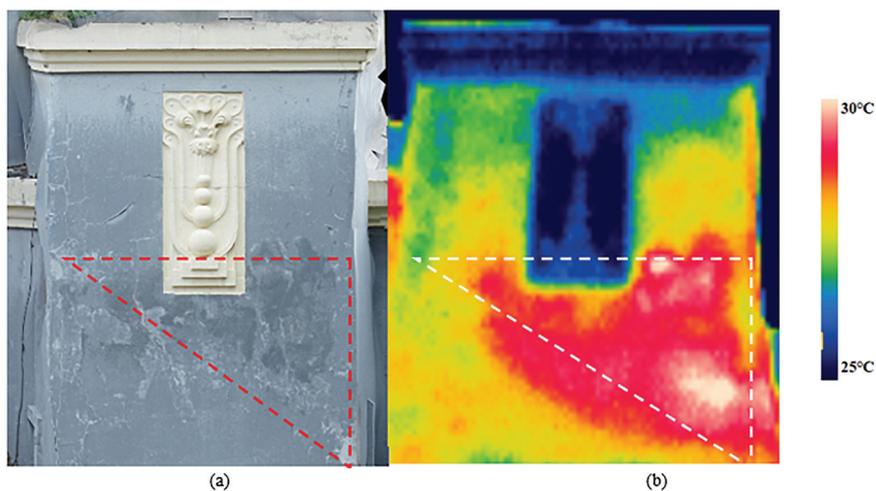
Figure 16: Pathological manifestations in region 2: (a) orthoimage; (b) thermogram.

Region 2, represented in Figure 16, was one of the regions where damages mapping showed the largest areas with efflorescence problems. The greater thickness of these elements can cause the upper part to accumulate excess moisture, resulting in infiltration and percolation through the platband, even causing the appearance of efflorescence.

Similar to the behavior of region 1, it was possible to observe in the thermographic image, in white and red, the presence of moisture in the lower right corner (Figure 16(b)). The greater thickness of the wall in the tower region and the lack of direct sunlight on the surface at the time of inspection facilitated the visibility of this phenomenon, considering that both factors reduce the process of water evaporation on the surface of the coating. Corroborating this, it can be seen that the extensions of moisture that propagate through the facade could be observed in the Thermography, however, they are not possible to be observed visually, so they were not represented in the damage map.

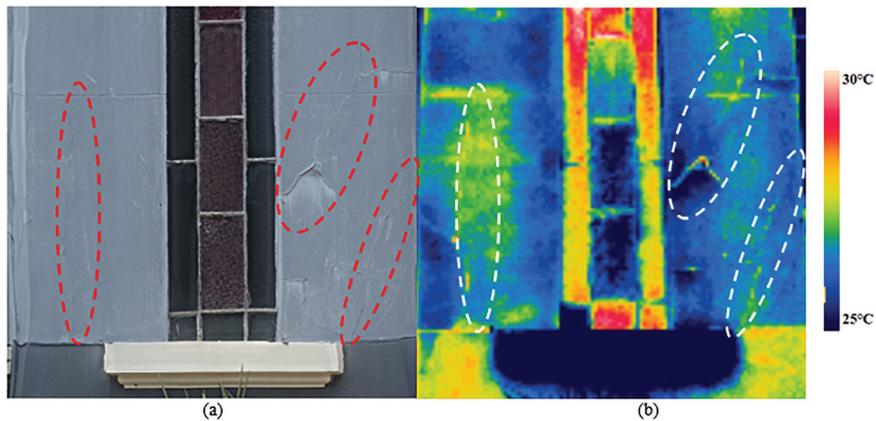
**Figure 17:** Pathological manifestations in region 3: (a) orthoimage; (b) thermogram.

The analysis of region 3 (Figure 17(b)) allowed us to verify the presence of cracks through thermographic inspection. In regions with dotted outlines in the orthoimage, the presence of white areas close to the cracks can be seen, which is an indication that part of the crack can contribute to the problems arising from the appearance of efflorescence. Thus, on the surface of the areas with fissures, there is a peeling effect of the paint that generates small voids along the path of the cracks, which allowed viewing them as warmer areas in the thermogram in relation to neighboring areas without defects. In the study developed by Bauer *et al.* [34], morning fissures were also detected as hottest areas in thermograms.

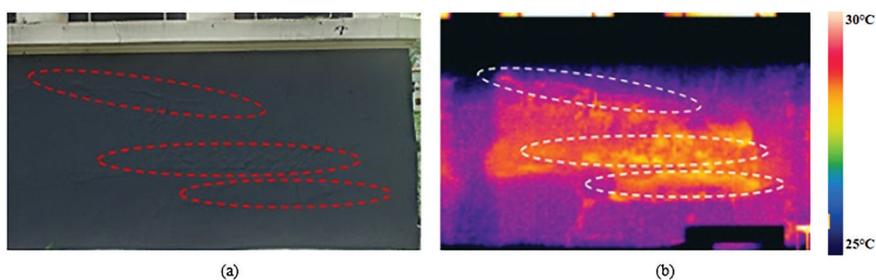
**Figure 18:** Pathological manifestations in region 4: (a) orthoimage; (b) thermogram.

It can be seen in the orthoimage of region 4 (Figure 18(a)), areas with the presence of paint blistering in the painting. The voids behind the paint layer, with the increase in ambient temperature in the early morning, generate higher temperatures when compared to areas without paint blistering (no defects), behavior detected in the thermographic image resulting from the inspection (Figure 18(b)).
