# EFFECTS OF HYDROELECTRIC DAM CONSTRUCTION ON LAND USE LAND COVER CHANGES IN BUI NATIONAL PARK, GHANA

The construction of hydroelectric dams in forest reserves has become a matter of concern for biodiversity conservationists. Spatio-temporal change of land cover in the Bui National Park was analyzed using indices calculations of the landscape based on land cover maps obtained from Landsat satellite images for pre-and post-dam construction periods. Significant changes in land cover following the dam construction were observed. Notable changes include the built-up areas and water body, while the forest area decreased. Significant reduction in rainfall and an increase in temperature were observed between the pre-and post-dam construction periods. Increased human activities within the reserve after dam construction could likely compound the changes in land cover.

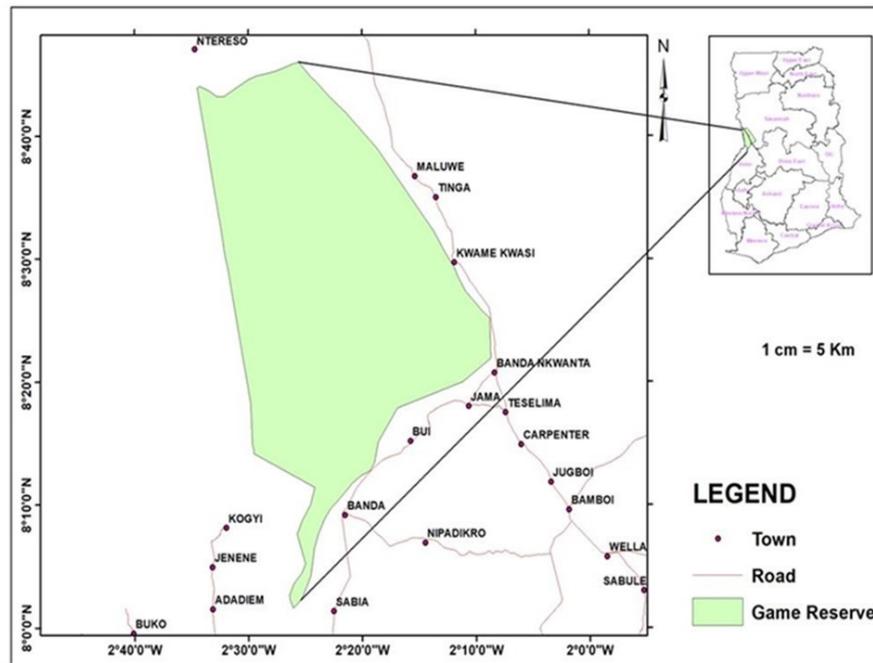
The Bui National Park (80 23' 13.2072" N, 20 22' 43.9788" W) covers an area of about 1,821 km<sup>2</sup> and it is located close to the Ghana-Cote D'Ivoire border (Figure 1). It is the third largest wildlife conservation area in Ghana. The Black Volta River bisects the park into two, with a portion lying in the north-western corner of the Bono Region and the other extending towards the southwestern part of the Savanna Region. The Park was gazetted in 1971 to primarily provide protection for the drainage basin of the Black Volta River as well as to conserve biodiversity in the entire designated area. The Park is renowned for its high biological richness. The vegetation of the area is mostly Guinea Savannah woodland with patches of Moist Semi-Deciduous Forest, harboring several animal species such as the hippopotamus (*Hippopotamus amphibius*), buffalo (*Syncerus caffer*), and roan antelope (*Hippotragus equinus*). The area experiences a relative humidity of about 75 % and yearly rainfall of 1,140 mm (APPIAH et al., 2017). The Bui hydroelectric dam is found at the southern end of the BNP. The dam is a gravity, roller compacted concrete type with a height of a 110 m above foundation and creating a reservoir of 12,350 million m<sup>3</sup> with a total surface area of 440 km<sup>2</sup> (HABIA, 2009; OBAHOUNDJE et al., 2018).

Figure 1 - Map of study area

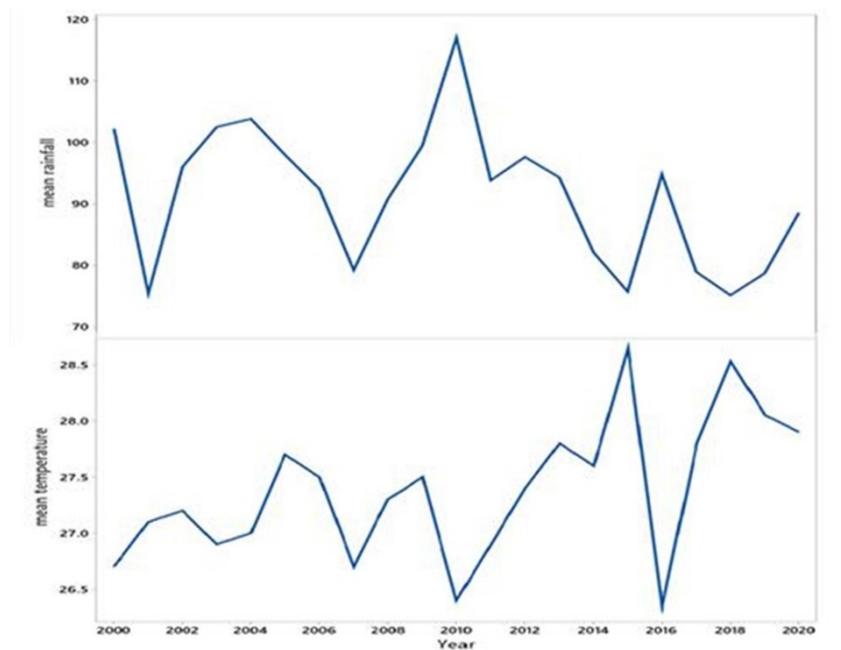
The highest decade mean temperature ( $27.69 \pm 0.219$  °C) was recorded for 2011–2020 compared to the decade 2000–2010 with  $27.16 \pm 0.108$  °C. The highest decade mean rainfall ( $93.96 \pm 3.094$  mm) was recorded for 2000–2010 compared to 2011–2020 with  $85.954 \pm 2.77$  mm. Results of Mann Whitney U test showed that the differences in the two decades were significant for mean rainfall ( $U = 24$ ,  $\rho < 0.05$ ) and mean temperatures ( $U = 22.5$ ,  $\rho < 0.05$ ).

Figure 2 - Trends of changes of mean rainfall (mm) and mean temperature (°C) from 2000 – 2020 at BNP

There was a negative correlation ( $r = -0.609$ , Figure 2), and estimated value from the series' cross correlation function (CCF) was significant ( $p = 0.003$ ) between the mean rainfall time series and the mean temperature time series for the study period.

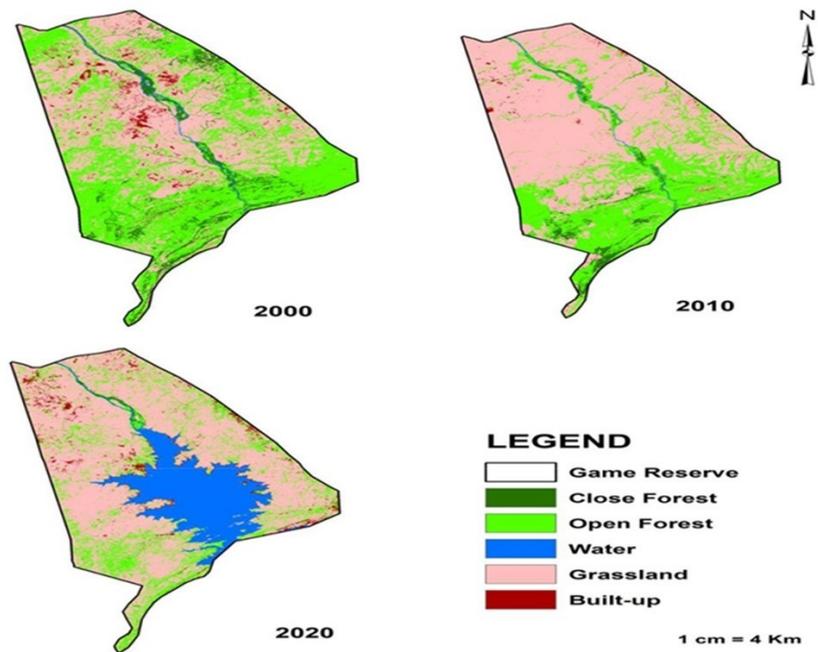
In all, five land cover types were identified, namely; built-up, close forest, grassland, open forest, and water body. A set of three different land cover maps covering the study area for the years 2000, 2010 and 2020 is shown in Figure 3.

Figure 3 - Land cover maps of the Bui National Park for the years 2000, 2010 and 2020.

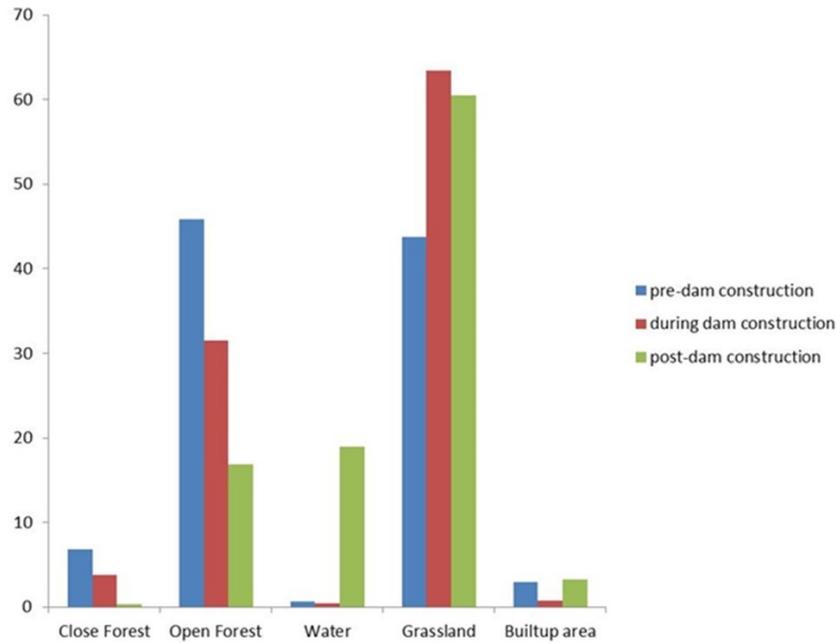
Kruskal Wallis test indicated significant difference among the various landcover classes ( $H = 9.33$ ,  $p < 0.05$ ) and Tukey's post hoc analysis revealed a significant difference between five out of the 10 pairs of the land cover classes. Before the dam construction, open forest occupied the largest portion of the total land area with 45.87 % (Figure 4). However, this changed during the post-dam construction, with grassland (60.54 %) occupying the largest percentage cover, followed by water body with 19.01 %.

Figure 4 - Percentage of area covered by each Land cover types; pre, during and post dam construction.

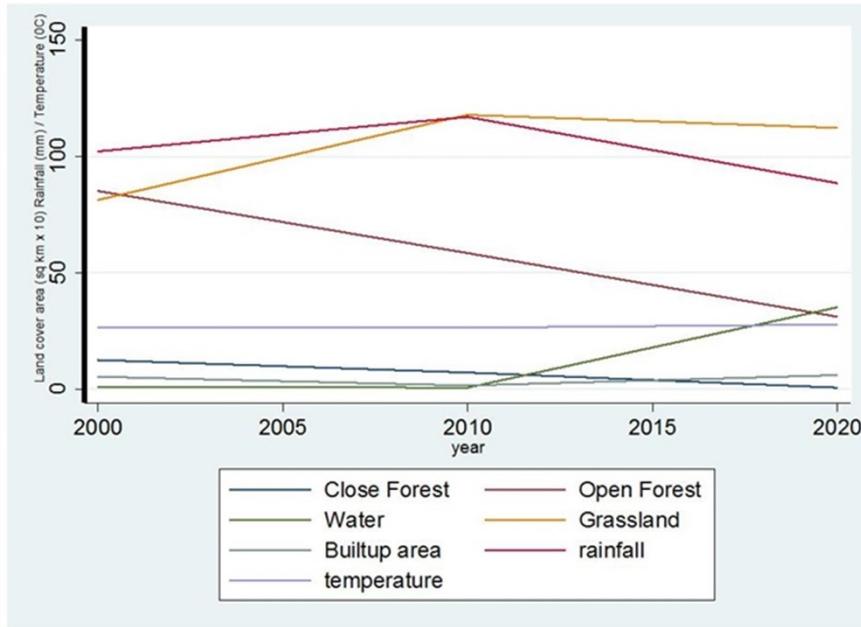
Land cover changes and climatic variables seem to follow a similar trend over the period after the dam construction (Figure 5). For example, a decrease in the amount of rainfall corresponded with a decrease in close forest and open forest. During the same period, water body, grassland and builtup area increased with marginal increase in temperature. Increase in water body results from the reservoir

created by the dam and grassland and builtup area is caused by forest degradation corresponding with temperature increase

Figure 5 - Land cover, rainfall and temperature changes with the construction of the dam
