Anthropic Changes to the Fluvial Landscape of São João Del-Rei, Minas Gerais, Brazil

Abstract

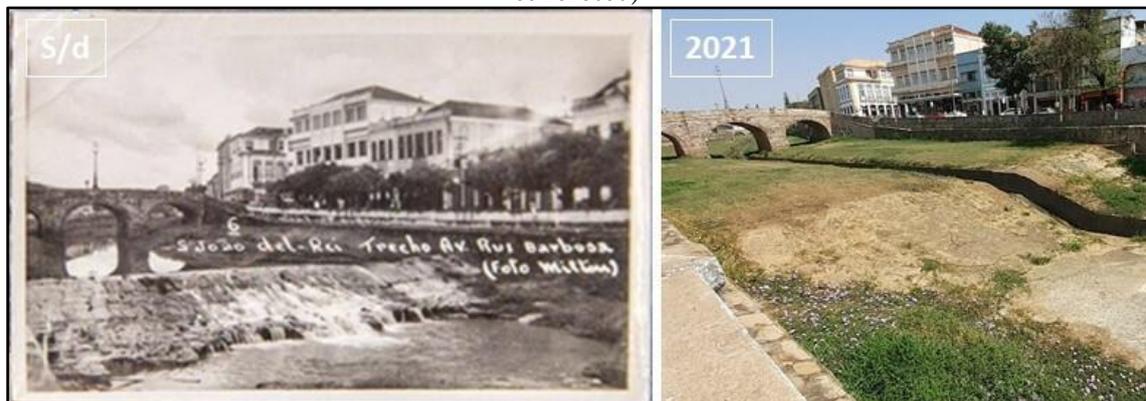
Figure 3 – Falls of the Lenheiro stream (natural in the black and white photograph and currently concreted)

It appears that the stream composed the local landscape along its lengthy bed, especially on its right bank (Figure 2). This inference is based on the toponym “beira da praia” (edge of the beach), used by the local population to refer to the river. In addition, the Lenheiro was characterized by stony stretches, where the exposed threshold and the slope break produced waterfalls (Figure 3).

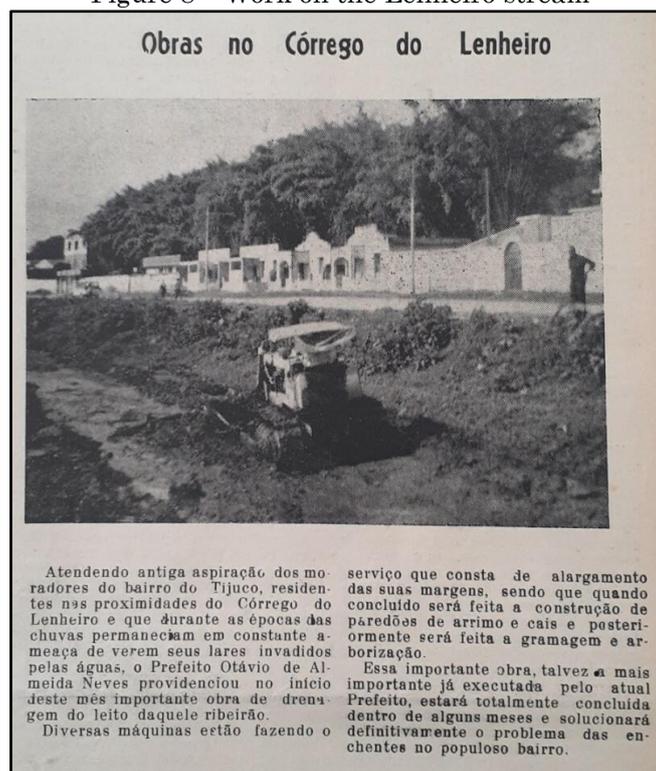
Figure 8 – Work on the Lenheiro stream

Thus, in June of the same year, new work was started as a remediation measure, widening the banks and deepening the bed of the Lenheiro stream, in the region of Tijuco (Figure 8) (OBRAS..., 1978b).

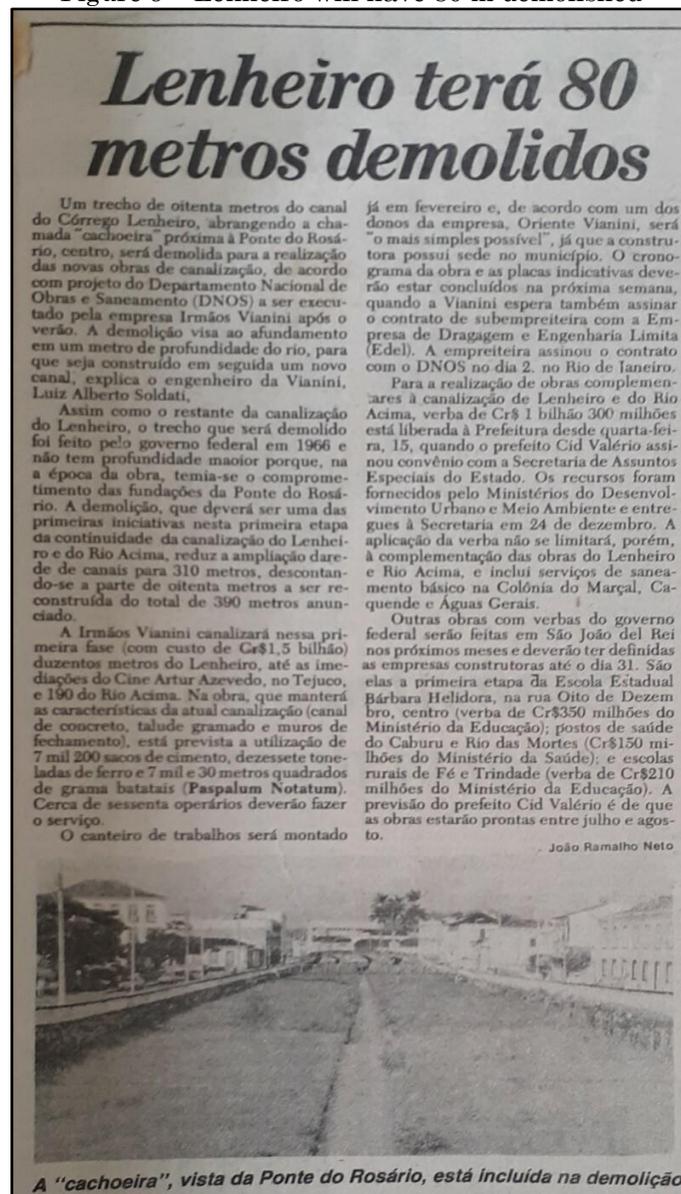
Figure 9 – Lenheiro will have 80 m demolished

Given the recurrent disasters and the inefficacy of the canalization, in 1986, 80 meters that had been constructed two decades before were demolished. The stretch that was destroyed was between the falls of the Rosário Bridge and the Biquinha Bridge (Figure 9),

which was justified by the need to deepen the canal by a meter (LENHEIRO..., 1986a), given that the canal did not support the volume of the river. The work extended the canal network 390 m in the direction of the Rio Acima creek, a tributary of the Lenheiro, including it in the canalization. Initially, the cost of the deployment was 1.5 billion Cruzeiros, which corresponded to 1.8 million minimum salaries at the time (BRASIL, 1986). The company responsible for the work was called Irmãos Vianini (Vianini Brothers in English) (LENHEIRO..., 1986a).

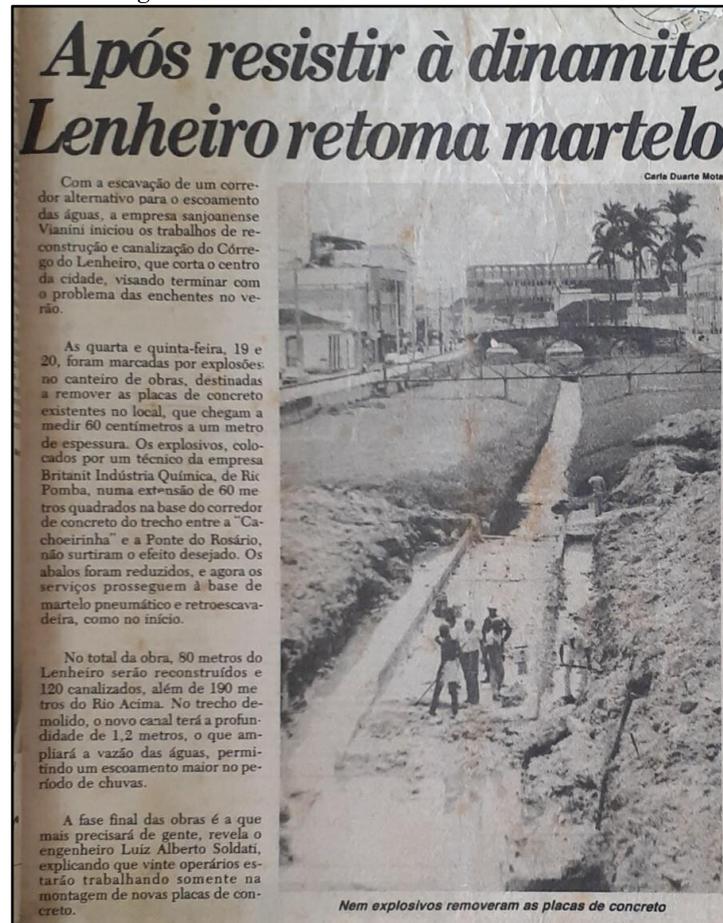
Figure 10 – Demolition of the canalization

The stretch had to be demolished using a jackhammer, as the dynamite was unable to

break part of the thick concrete (Figure 10) (APÓS..., 1986b).

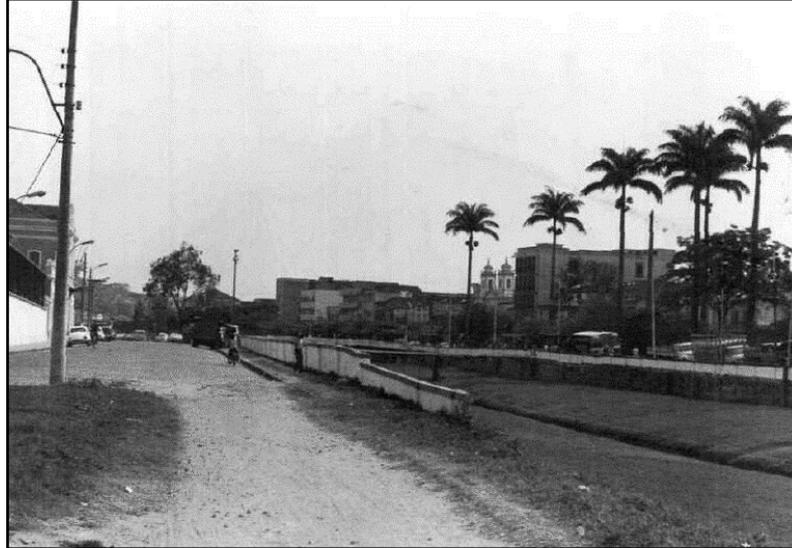
Figure 11 –Lenheiro stream in the vicinity of the Railway Station – 1980s

In this period, canalization finished in the vicinity of the railway station (Figure 11), where the concreted channel and the river returned to the natural bed (Figure 12).

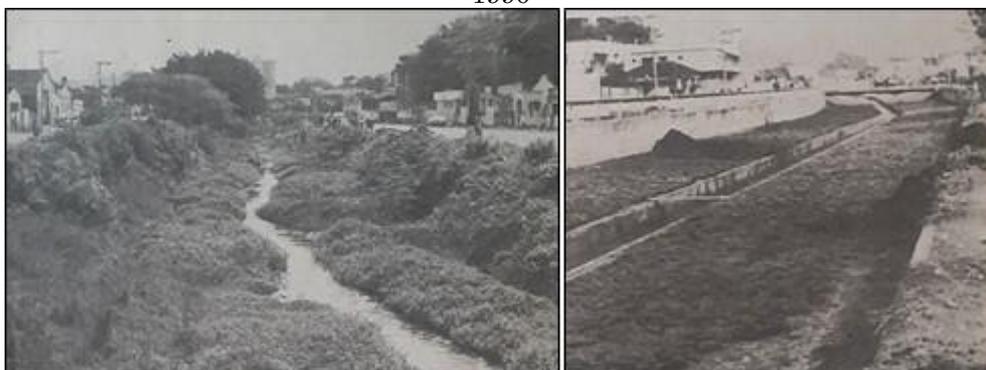
Figura 13 – Canalization of the Lenheiro stream in the Tijuco neighborhood, Rossini Bacarini street, 1990

At the beginning of the 1990s, the canalization work extended upstream, close to the Biquinha Bridge and the confluence with the Rio Acima creek. According to the Tribuna Sanjoanense newspaper (1991), the work was

carried out from the Rossini Bacarini street (Point B – Figure 1) in the direction of the Minas Clube, approaching the São João street (Point A - Figure 1), both in the Tijuco neighborhood (Figure 13).

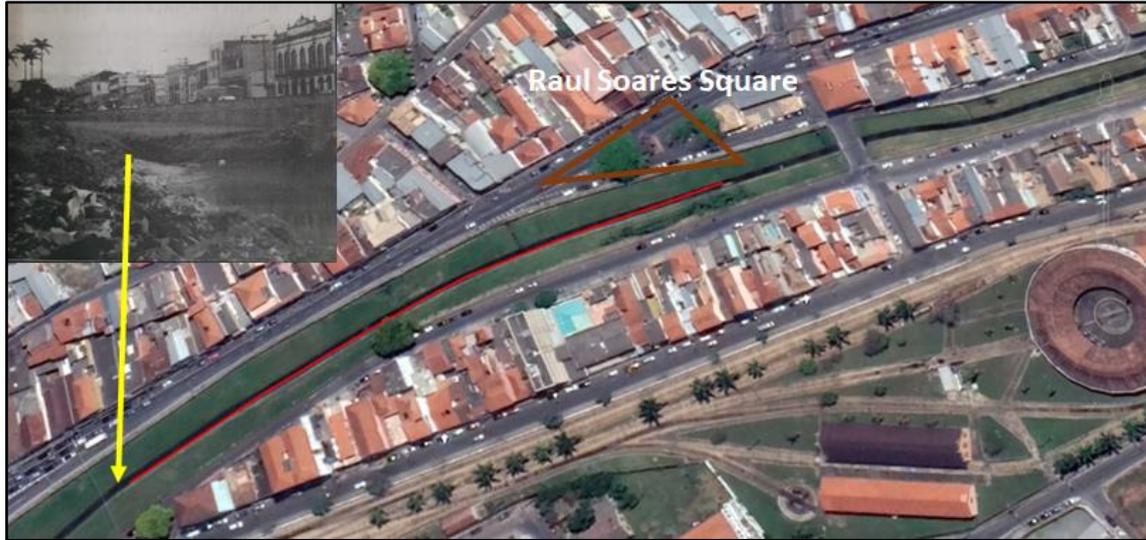
Figure 14 – Extension to the canalization work of the Lenheiro stream, 1995

In 1995, the city council announced that it would not wait for federal funds and would resume canalization up to Raul Soares Square

using municipal resources (CANALIZAÇÃO..., 1995). The stretch in question was around 200 meters, indicated in red below (Figure 14).

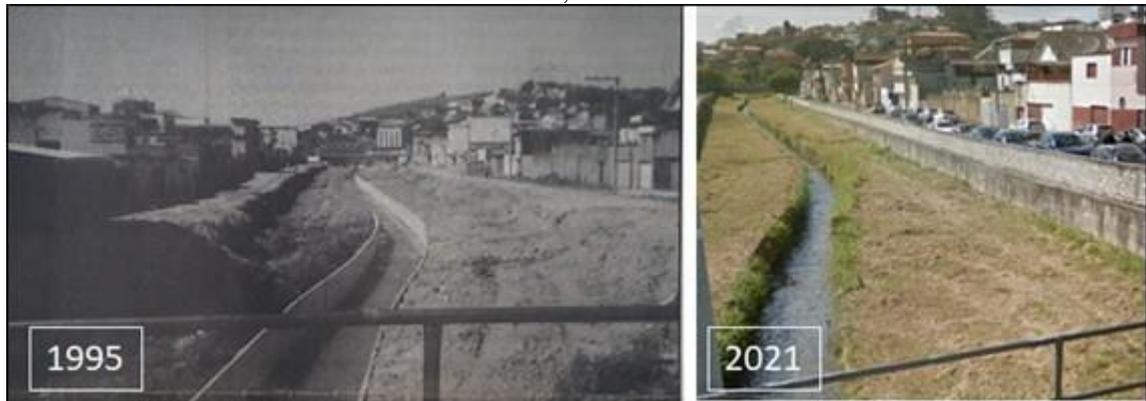
Figura 15 – Canalized stretch of the Lenheiro stream between the roads Antônio Josino and Aldo Zerlotine, 1995/2021

According to the *Jornal Tribuna Sanjoanense* newspaper (1995), the work was carried out at a rapid pace, and in November 1995, was directed downstream in the direction of the confluence with the Água Limpa creek, and upstream in the direction of Águas Férreas. Figure 15 makes it

possible to see that, at that time, the work had already been carried out along the entirety of the banks beside the roads Antônio Josino de Andrade and Aldo Zerlotine, located approximately 1000 m from the confluence.

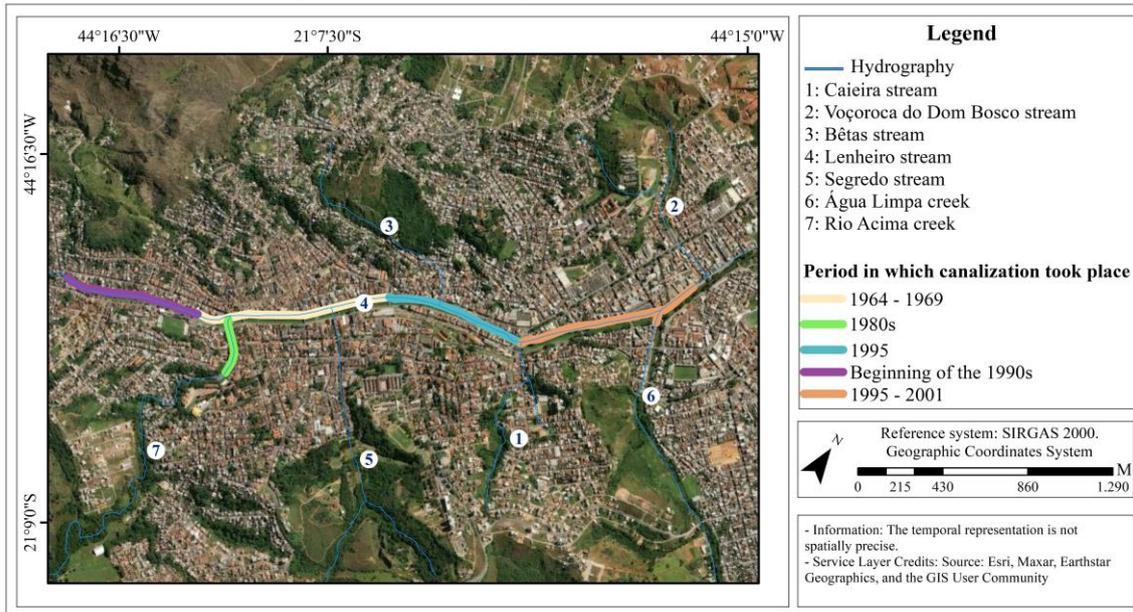
Figure 16 - Summary of the canalization history.

Despite the rapid pace of the work, the canalization only reached its current state in 2001, when the stretch in the vicinity of the bus terminal was finished. This also included around 32 m of the Água Limpa creek upstream

and 180 m downstream of the confluence with the Lenheiro. In summary, the canalization of the Lenheiro stream took 37 years to reach its current state (Figure 16).

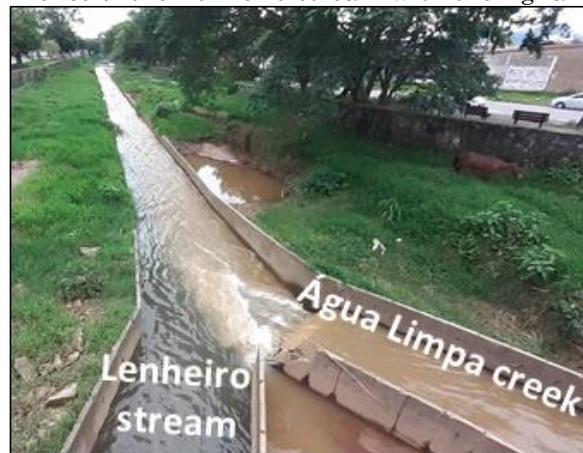
Figure 17 – Confluence of the Lenheiro stream with the Água Limpa creek, 2021

Among the modifications carried out during the work, the alteration of the base level of the two rivers stands out. As already mentioned, the Lenheiro stream is a tributary of the Água Limpa creek, that is, the former drains into the latter. However, after deepening the bed of the

Lenheiro stream for canalization and the removal of accumulated sediments, its base level was lowered and its course anthropically inverted to make the Água Limpa creek drain into the Lenheiro (Figure 17).

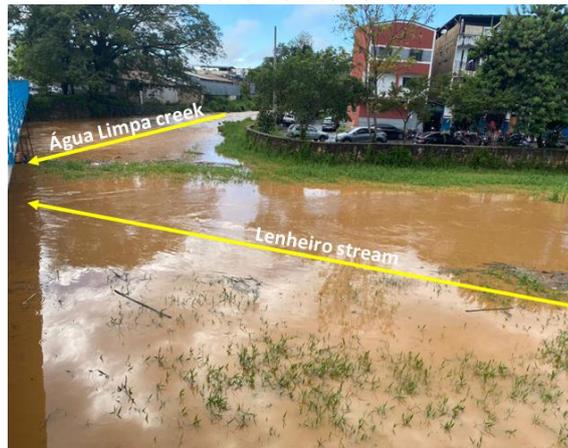
Figure 18 – Volumetric and energetic difference and the backwater effect of the Água Limpa creek on the Lenheiro

According to Guerra (1993), any variation in the base level of a river can lead to the resumption of the headward erosion process and erosion along the drainage axes, in addition to alteration of the dynamic balance of the channel (BISHOP, 1995; BOTELHO, 2011). Thus, it can

be inferred that the inversion of the base level aggravated the backwater effect in the area of the confluence, given that the Água Limpa creek has a visibly greater volume of water impounding the Lenheiro (Figure 18).

Another explanation for the backwaters is the canalization flowing into a larger receiver (MALHEIROS, 2018), such as the Água Limpa creek, the widening of the channel, and the interventions on the banks (FORNASARI FILHO et al., 1992). This appreciably reduced the carrying capacity for outflows in the projected canal (MALHEIROS, 2018).

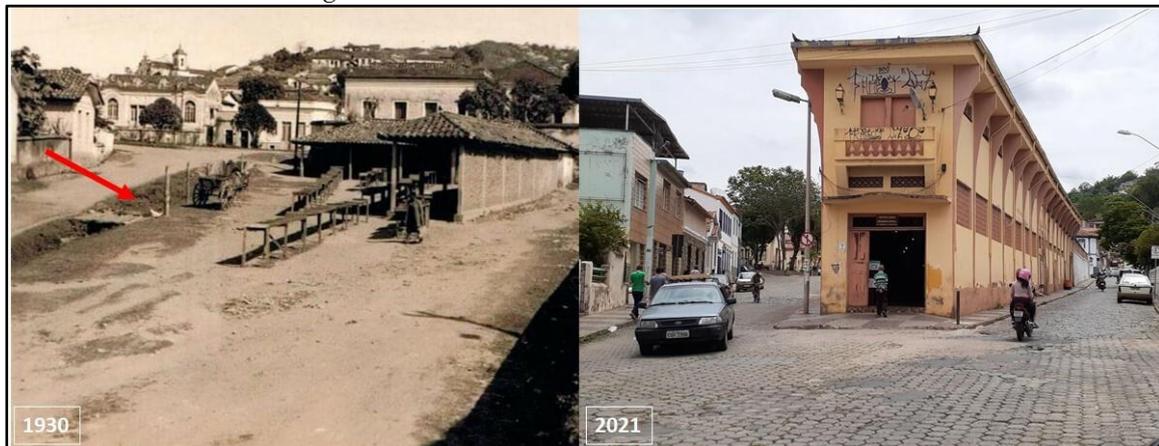
Figure 19 –Morro das Bêtas stream in 1930 and 2021.

The Morro das Bêtas stream (Figure 19) drained parallel to the Mercado Municipal (Municipal Market) and was a tributary to the Lenheiro stream on its left bank. Nowadays, this tributary is canalized under the Travessa Lopes Bahia cross street, and, according to the Tribuna Sanjoanense newspaper (1999), has its water pumped by the Departamento Autônomo Municipal de Água e Esgoto (Autonomous Municipal Department of Water and Sewage) (DAMAE) to supply the 8 de Dezembro Avenue.

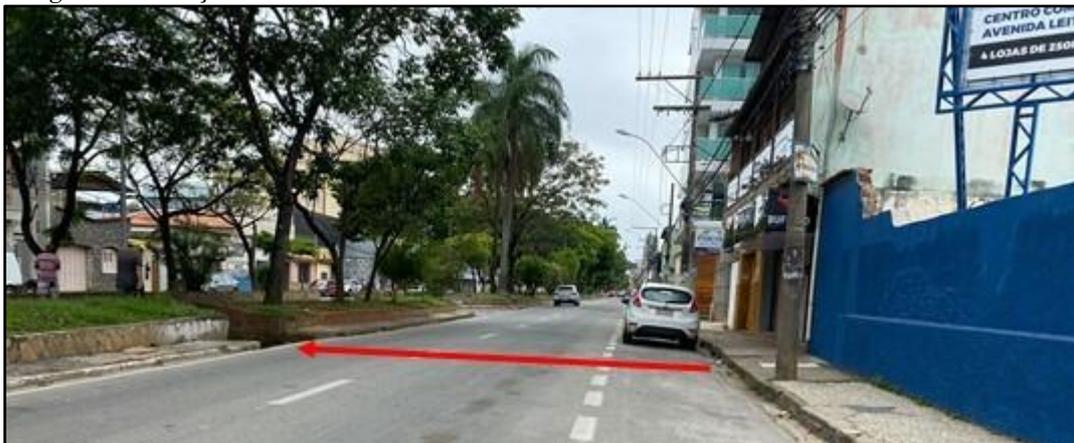
Figure 22 –Voçoroca do Dom Bosco stream canalized under Leite de Castro Avenue

Dom Bosco stream (Figure 21), which cuts Leite de Castro Avenue (Figure 22) under buildings to subsequently drain into the Água Limpa creek downstream of the confluence with the Lenheiro stream.

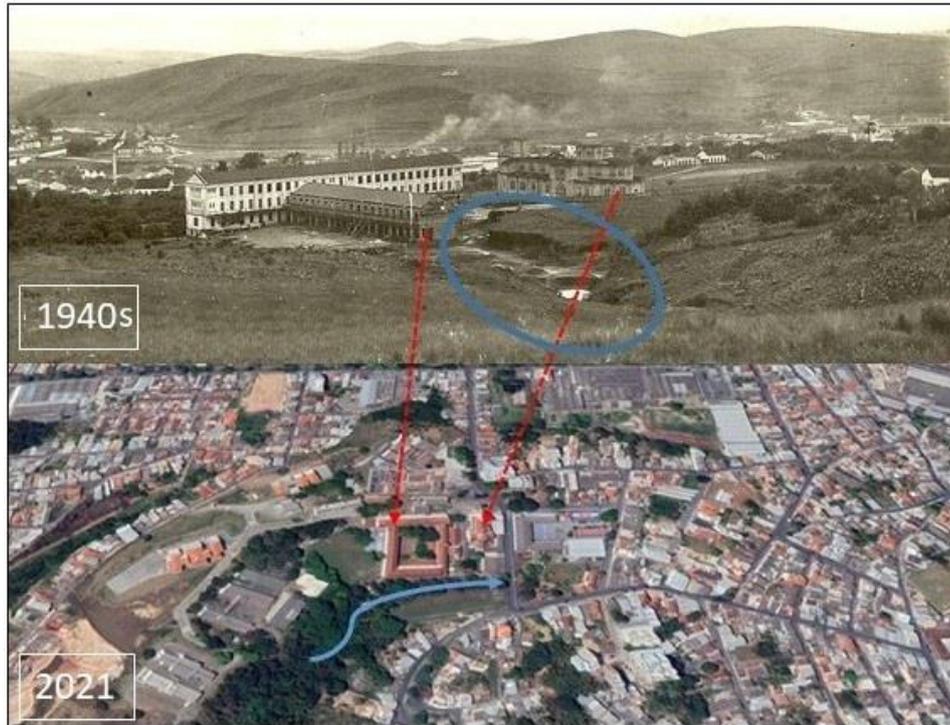
Figure 23 – Dom Bosco stream

There is also evidence of the existence of another canal, which, until 1940, was part of the landscape of Campus Dom Bosco (Figure 23). However, there are no further records or clear

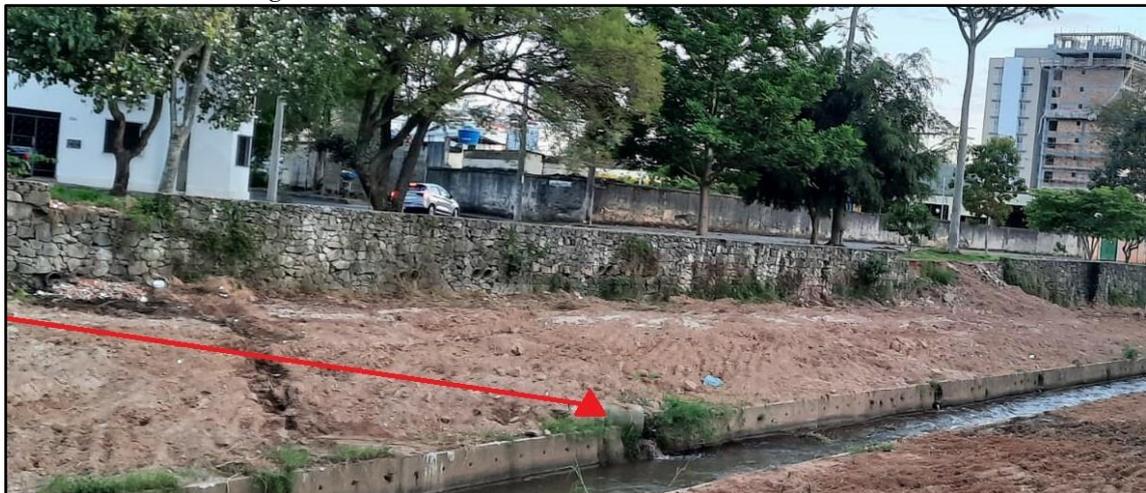
Figure 24 – Possible outflow of the Dom Bosco stream

in the direction of the Frei Cândido street (Point K- Figure 1) to drain into the Água Limpa creek,

downstream of the mouth of the Lenheiro stream (Figure 24).

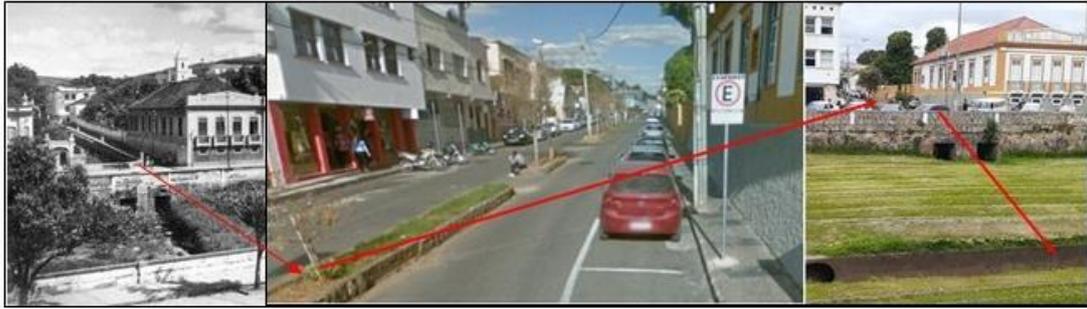
Figure 25 – Segredo stream

Regarding the Segredo stream, this is found canalized and plugged under the Andrade Reis street (Figure 25). This canalization starts with a barrier deployed inside the 11º Batalhão de Infantaria (11th Infantry Battalion) (Point F – Figure 1) and drains on the right bank of the

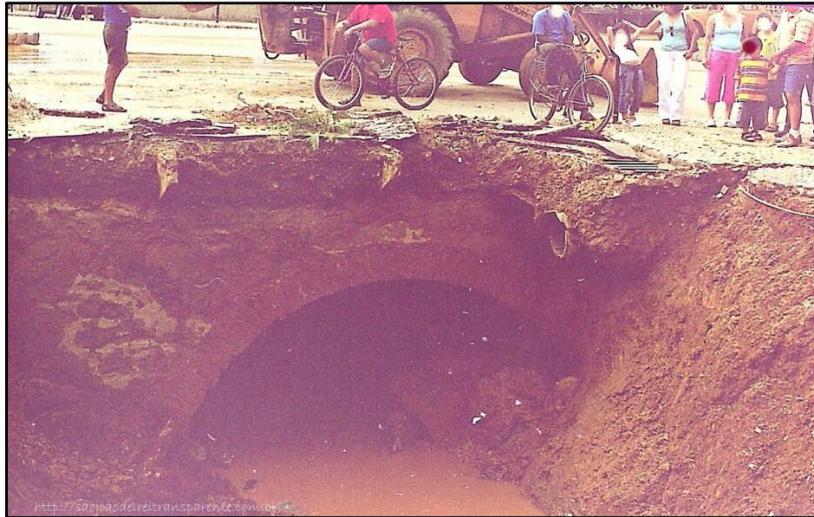
Figure 26 – Misericórdia Bridge

Lenheiro stream, close to the Teatro Municipal (Municipal Theater) (Point 6 – Figure 1). During a storm event in 2003, an old bridge (Figure 26) over said canal that had been buried through canalization and reclaimed land was exposed by subsidence.

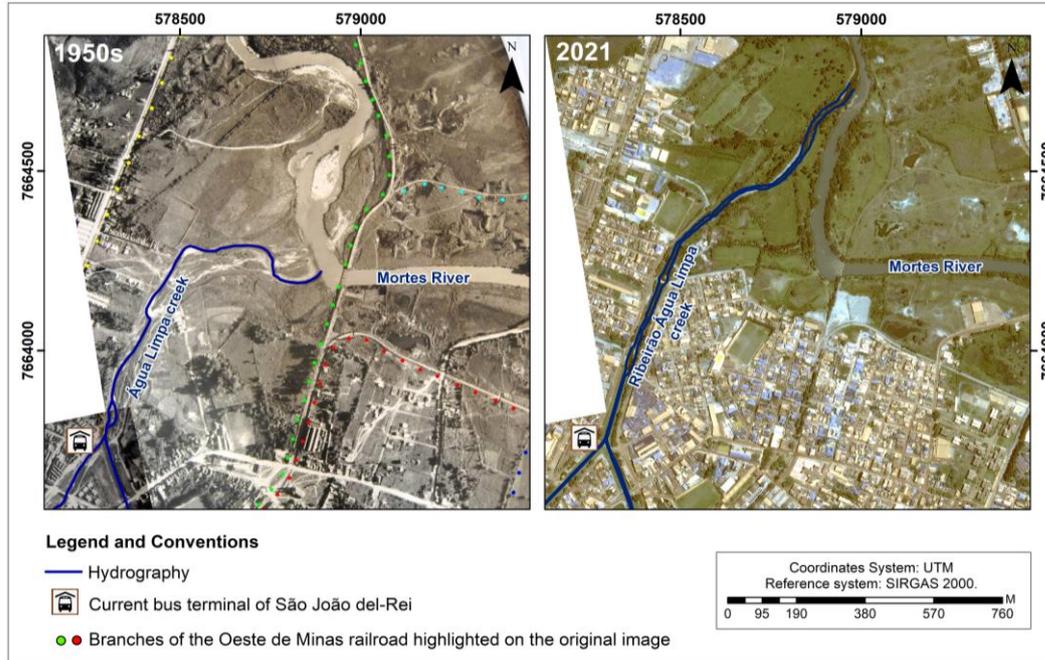
Figure 27 – Modifocation map of the fluvial landscape of the mouth of the Água Limpa creek

The modification of the mouth of the Água Limpa creek is noteworthy for the absence of information, records, and even knowledge on the part of the population. Identification of this intervention (Figure 27) occurred through observation of aerial images from the 1950s,

available in the Antiga São João del-Rei Facebook group. Access to the image and the use of geotechnology made it possible to identify and represent the modification on the natural landscape of the mouth of the Água Limpa creek.

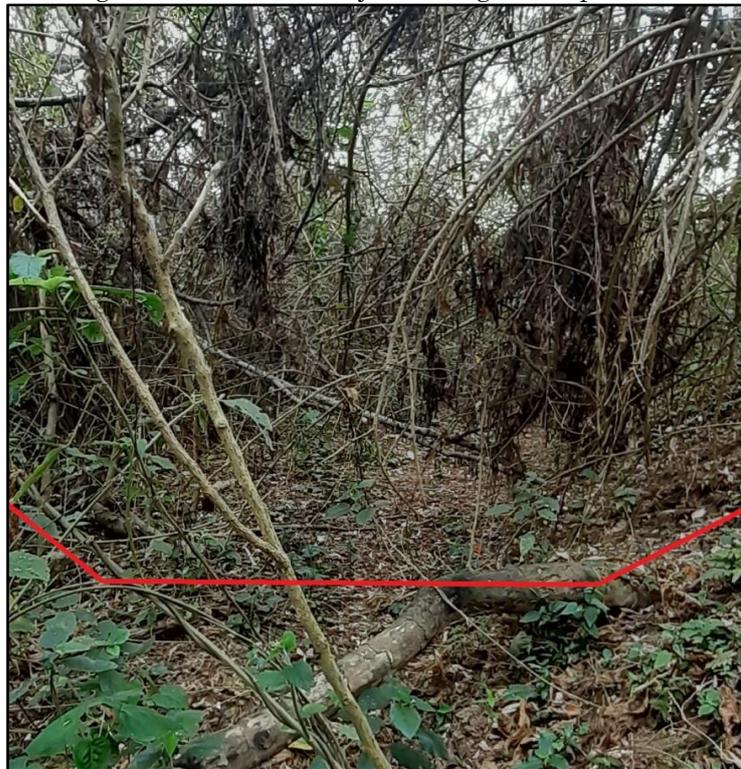
Figure 29 – Filled valley of the Água Limpa creek

Currently, the filled valley and the marginal dykes of the old bed of the Água Limpa can still be identified in the field (Figure 29).
