## Damages mapping of façade using Aerophotogrammetry and Thermography Inspection: Zoroastro Artiaga Museum – Art Deco in Brazil

**Keywords:** Art Deco Architecture; Non-destructive techniques; Aerophotogrammetry; Thermographics images; Damages map.

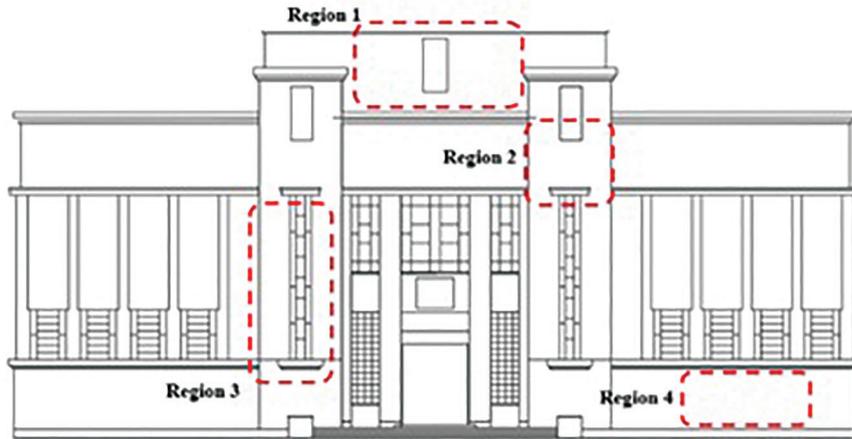
The thermographic images were captured at ground level at a distance of 4.5 m from the façade, without the use of UAV and, for the application of this method, four regions of the façade with more accentuated pathological manifestations were recorded. Figure 8 shows the regions evaluated and studied using Infrared Thermography.

Figure 8: Regions evaluated with Infrared Thermography of the façade of the Zoroastro Artiaga Museum.

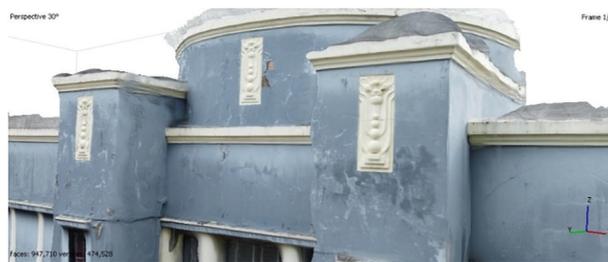
In Figure 11, a more enlarged image of the façade is shown in perspective, in which the ornaments can be seen in detail, as well as some of the pathological manifestations: paint peeling, chromatic alteration and efflorescence.

**Figure 11:** Photogrammetric model of the main façade of the Zoroastro Artiaga Museum: platform area.
