ORIGINAL ARTICLE

## ACCESSIBILITY TO BASIC HEALTH UNITS FOR PEOPLE WITH PHYSICAL DISABILITIES

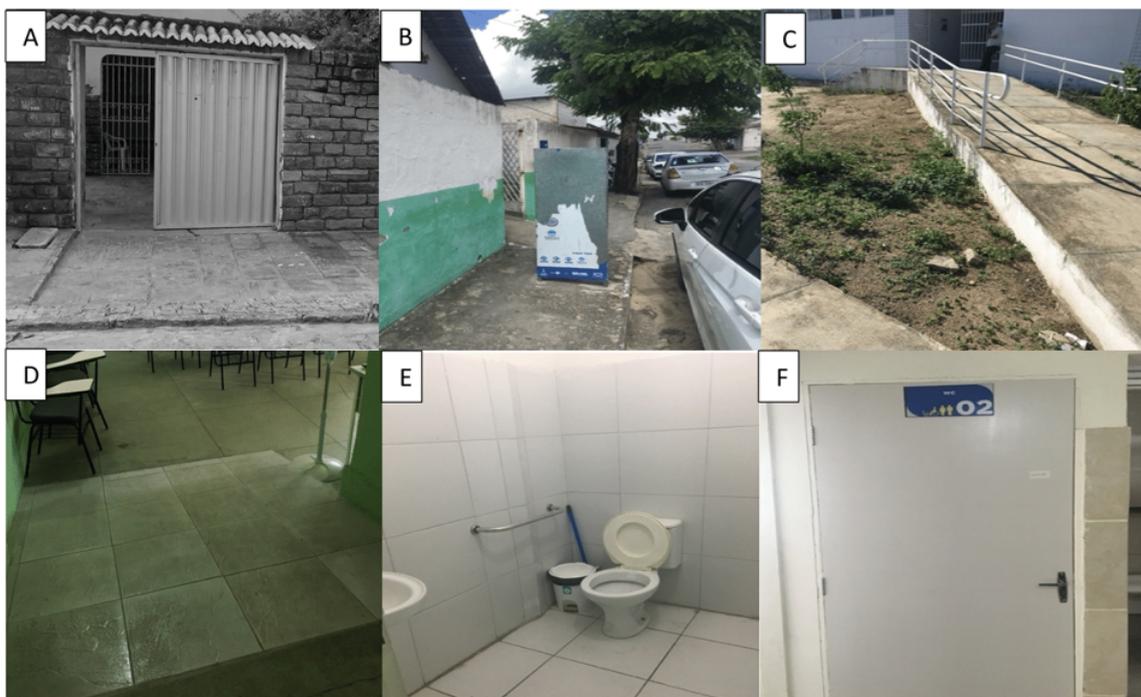
Figure 1 shows images taken in loco at the BHUs investigated. Images A and B confirm the lowering of sidewalks, unevenness, and the use of a house for the operation of a unit. Images C and D show aspects of the entrance and interior of the BHUs of the investigated municipality, with the predominant use of access ramps. Images E and F show sanitary facilities of the BHUs, showing that the bathrooms are used by both sexes and without bars on the back side of the toilet bowl.

Figure 1 - Demonstration of external and internal accessibility conditions of the PHU in a medium-sized municipality in the Northeast of Brazil. Campina Grande, PB, Brazil, 2020. Source: Authors (2020)
